**NCHRP REPORT 350 TEST 4-21 OF THE
ALASKA MULTI-STATE BRIDGE RAIL THRIE-BEAM TRANSITION**

Contract No. T97232
Research Project 404311-5

July 1999

**TEXAS TRANSPORTATION INSTITUTE
THE TEXAS A & M UNIVERSITY SYSTEM
COLLEGE STATION, TEXAS**

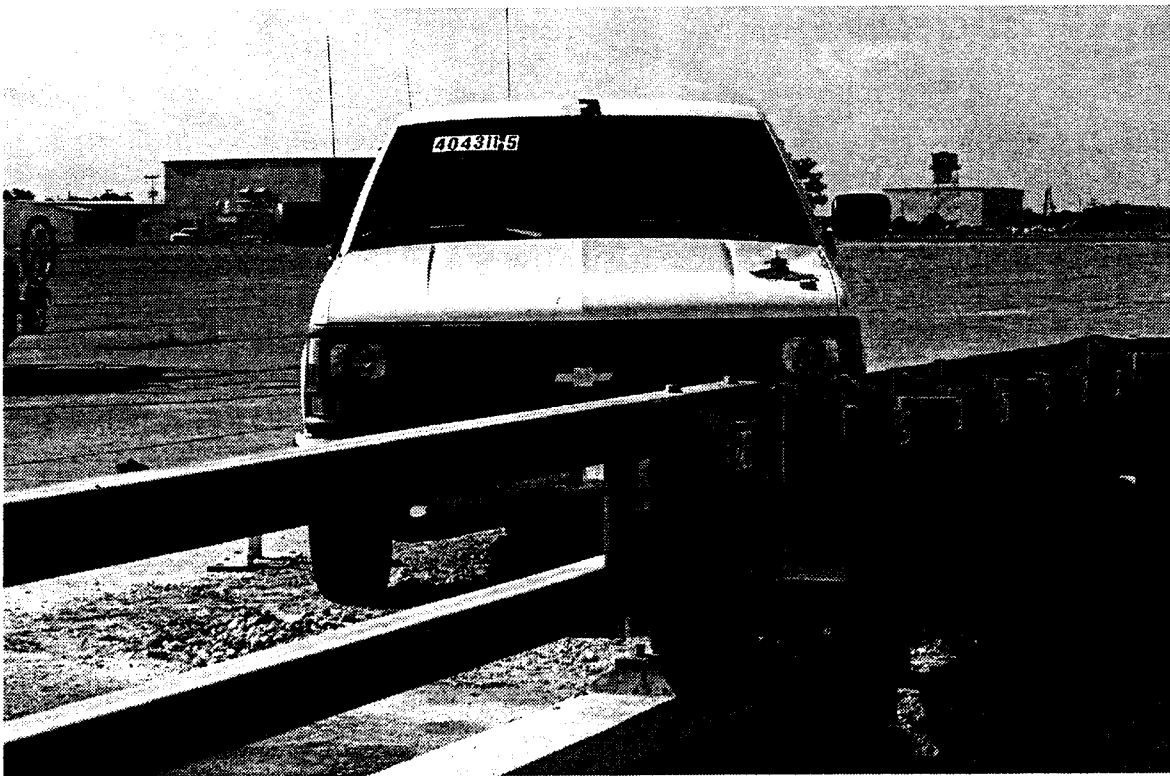
Figure 4. Vehicle/installation geometrics for test 404311-5.

The 2000P vehicle, while traveling at a speed of 100.6 km/h, impacted the transition at 2.1 m upstream of post 20 (the first bridge rail post) at an angle of 25.4 degrees. Shortly after impact posts 16, 17 and 18 moved and at 0.007 s, post 15 moved. At 0.010 s, post 19 moved, and at 0.023 s, the left front wheel steered toward the transition. By 0.033 s, the left front tire was traveling parallel with the rail element, and by 0.036 s, the left front tire began to angle underneath the rail element. At 0.044 s, the vehicle began to redirect and post 19 moved, and at 0.046 s, post 13 moved. By 0.054 s, the concrete began to crack at the rear of the test installation, and by 0.100 s, the right front tire lost contact with the ground. The rear of the vehicle contacted the rail element at 0.199 s, and at 0.210 s, the right rear tire lost contact with the ground. At 0.214 s, the vehicle was traveling parallel with the transition at a speed of 75.0 km/h, and at 0.218 s, the left front tire lost contact with the ground. The left front tire lost contact with the rail element at 0.269 s. The rear of the vehicle lost contact with the transition at 0.343 s, and was traveling at a speed of 75.6 km/h and an exit angle of 1.7 degrees. The left front, right rear and right front tires returned to the ground surface at 0.449 s, 0.569 s, and 0.579 s, respectively. Brakes on the vehicle were applied at 2.2 s after impact and the vehicle subsequently came to rest 58.5 m down from impact and 3.0 m behind the test installation. Sequential photographs of the test period are shown in appendix C, figures 13 and 14.

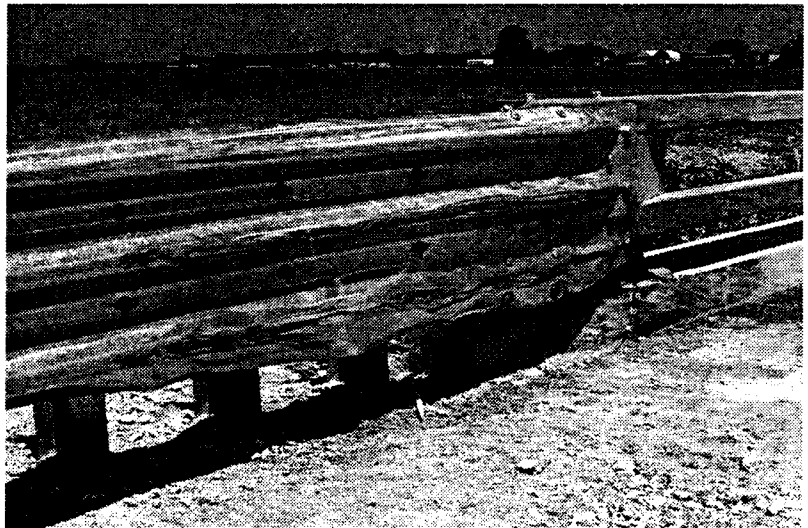
Figure 7. Installation after test 404311-5.

The Alaska Multi-State Bridge Rail Transition received moderate damage as shown in figure 6 through 8. Tire marks were on the face of the curb at post 20 for a total of 1.1 m. The front connection bolt on the end shoe to the lower tube was pulled out. Cracks in the deck radiated outward from the bolts of the base plate at post 20 (the first bridge rail post). Total length of contact by the vehicle with the transition and bridge rail was 3.9 m. Maximum dynamic deflection of the top of the rail element was 131 mm and maximum permanent deformation was 50 mm at post 19.

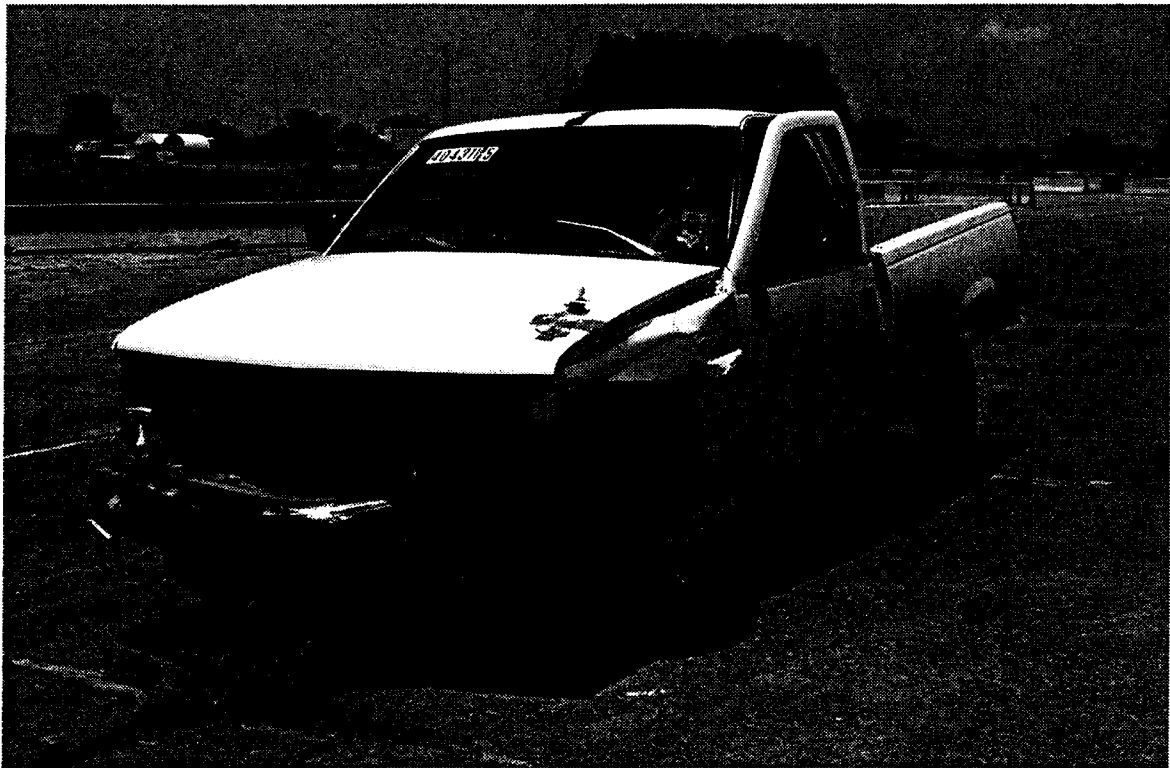
Figure 9. Vehicle after test 404311-5.

The vehicle sustained damage as shown in figure 9. Structural damage included upper A-arm, sway bar, left upper ball joint, left outer tie rod, floor pan and frame. The left front tire, wheel and quarter panel were crushed. The front bumper, hood, grill, radiator, and fan were deformed. The left rear quarter panel, tire rim and left rear bumper were also deformed. The windshield was shattered and the instrument panel was deformed. The driver's side door was pulled open 110 mm and the cab of the vehicle shifted outward 90 mm on the driver's side. Maximum exterior crush to the vehicle was 570 mm at the front bumper and 340 mm the left side of the bumper. Maximum deformation of the occupant compartment was 130 mm (12 percent reduction in space) to the floor pan behind the driver's seat to the right at the inside seat belt bolt and 104 mm to the lower portion of the kick panel area. The interior of the vehicle is shown in figure 10. Exterior vehicle crush and occupant compartment measurements are shown in appendix B, tables 2 and 3.

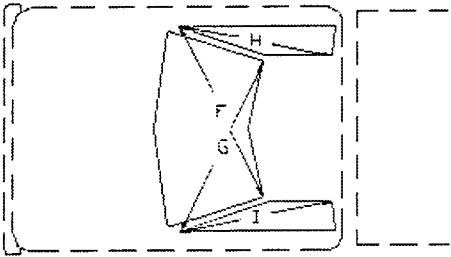
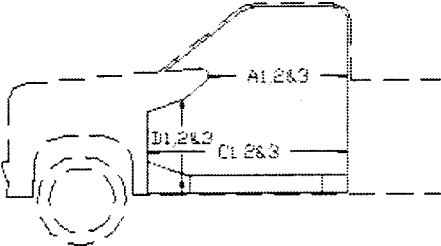
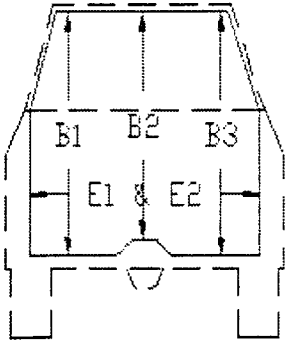
A1	1040	1036
	A2	1084	1091
	A3	1045	1051
	B1	1075	1060
	B2	1065	935
	B3	1082	1073

C1	1385	1341
	C2	1262	1245
	C3	1372	1372
	D1	309	370
	D2	97	80
	D3	310	316

E1	1597	1605
	E2	1592	1620
	F	1470	1455
	G	1470	1460
	H	900	900
	I	900	880
	J	1524	1420
