GEOTECHNICAL FOUNDATION REPORT

SNOW REMOVAL EQUIPMENT BUILDING AMBLER AIRPORT REHABILITATION (AIP 3-02-0354-2014/61303) AMBLER, ALASKA

31 JANUARY 2014

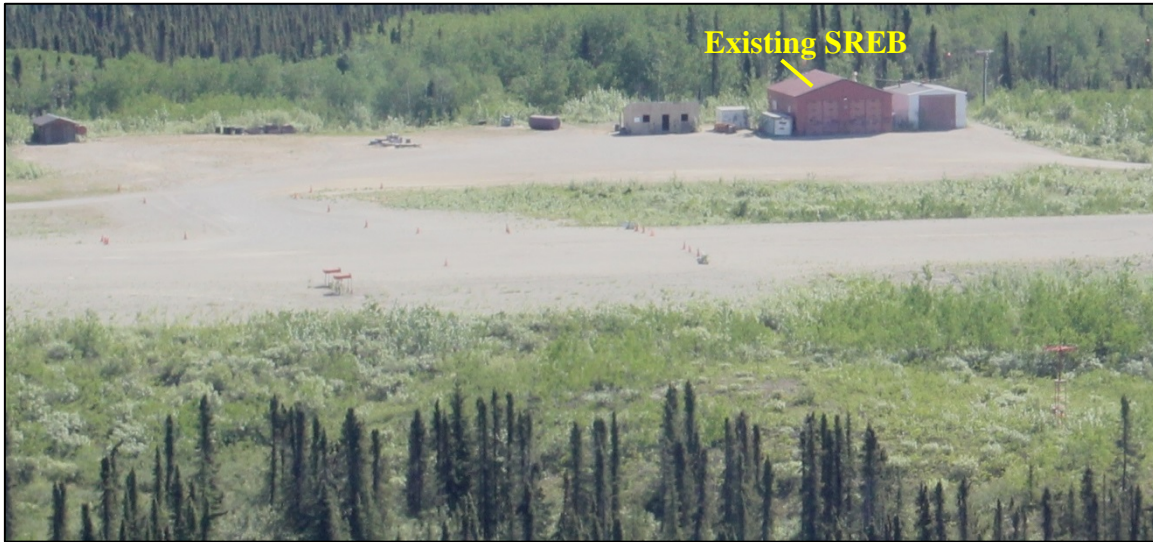
FIGURE 2: AMBLER AIRPORT APRON (DOT&PF)

The existing SREB in the southeast corner of the airport apron will be demolished and replaced with a new, single-story steel framed structure with a concrete floor, covering an area of about 44 ft x 50 ft, and supported on a shallow concrete foundation.

The apron was originally constructed in 1978. The DOT&PF record drawings indicate that all organic matter was removed within five feet of the finish grade across the entire apron; however, neither the final grade elevations or as-built fill thickness were noted. The original equipment storage building was constructed along the south end of the apron, next to the end of the airport access road, and just west of the present SREB.

The apron was improved in 1991/92. That work included: ‘squaring-out’ the southeast corner of the apron using borrow containing ≤ 10 percent particles, by mass, passing the No. 200 sieve (P200); and erecting a new SREB (just east of the original building) on a subgrade consisting of a minimum 6-inches of ‘aggregate surface course’ over a minimum 12-inches borrow containing a P200 ≤ 10 percent. Note that the DOT&PF record drawings did not indicate if or how the ground surface was to be prepared (e.g. no information of clearing and grubbing), the final apron and building floor elevations, or the as-built fill thickness.

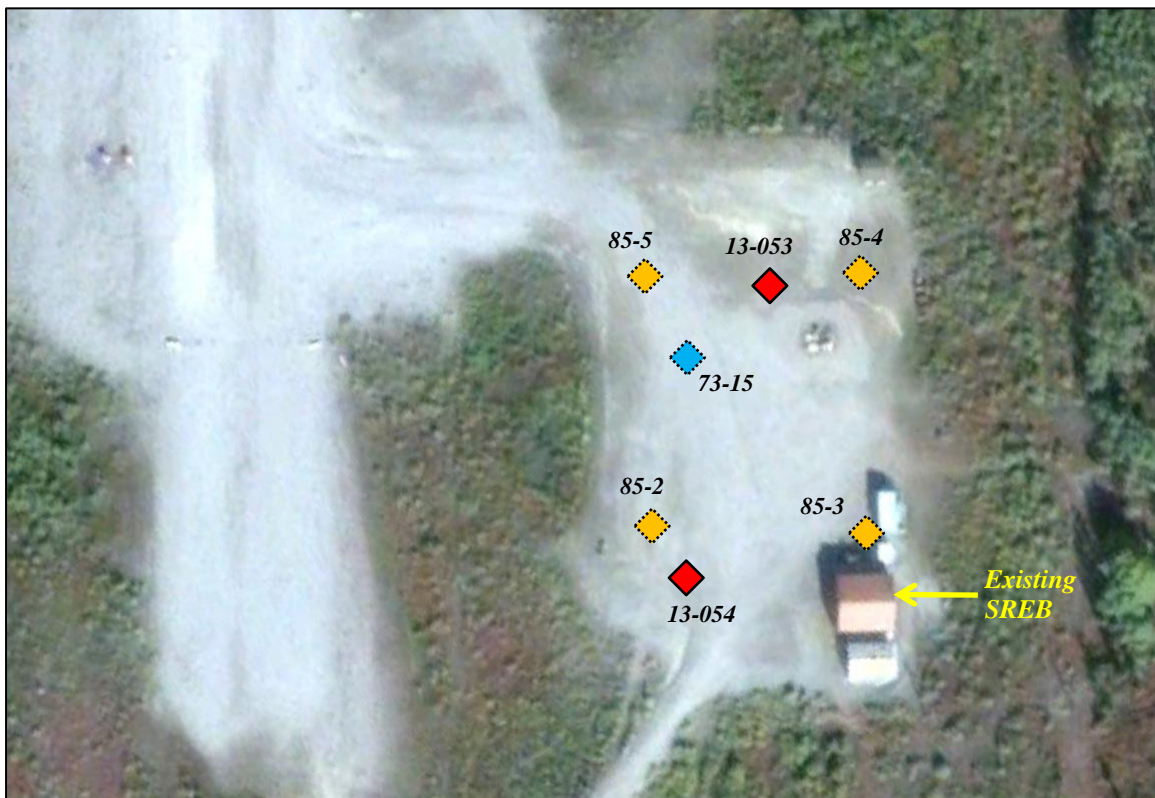
FIGURE A1: APPROXIMATE LOCATION OF DOT&PF APRON TEST HOLES

The DOT&PF completed geotechnical test borings at the Ambler airport in 1973, 1985, 1986, and 2013 (DOT&PF 1973, 1986, 2013). The following summarizes the seven test holes drilled to-date within the apron (Figure A1); the DOT&PF logs are provided on pages A-2 through A-4.

Test Hole No.	Date Drilled	Total Depth, ft	Frozen Soil, ft
053 054	Feb 2013	20 16	0 – 20 0 – 16
2 3 4 5	Sep 1985	15 11 11 11	11.5 – 15 10 – 11 Not reported Not reported
15	Jul 1973	10	Not reported

The DOT&PF completed geotechnical explorations within the apron in 1973 (one boring), 1985 (four borings), and 2013 (2 borings) (see Appendix A). Based on that information, the general soil column under the new SREB site reportedly consists of about six inches ‘base course’; overlying silt with variable sand to a depth of at least 20 feet. The following paragraphs summarize the reported characteristics of these two general soil units:

Ambler is in an area of mapped continuous permafrost (Jorgenson et al., 2008). At the airport, the depth to permafrost appears to range from several feet to over 30 feet deep; and may be as shallow as about 10 to 12 feet under the apron (e.g. DOT&PF borings 85-2 and 85-3; see Appendix A). All of the soil samples recovered from the two 2013 DOT&PF apron borings (13-53 and 13-54; drilled in February) were in a frozen state (seasonal and/or permafrost), and described as either ‘poorly bonded or friable’ (*Nf*) or ‘well bonded with no excess or visible pore ice’ (*Nbn*). However, those samples were collected from auger cuttings (i.e. completely disturbed, and accurate sample depth unknown), so there is a possibility that the permafrost contains some segregated ice forms (which could indicate a potential for detrimental thaw settlements under the new SREB).
